INDEPENDENT CONDITION ASSESSMENT OF THE IRMA STERN MUSEUM

THE FIRS - ROSEBANK
CAPE TOWN

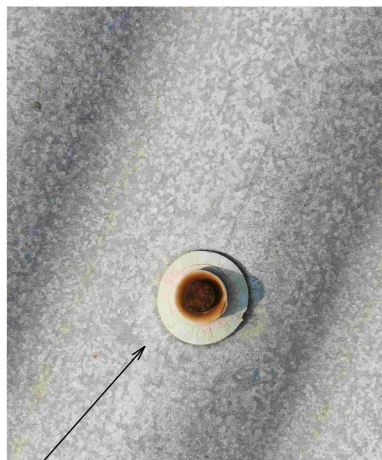
Replace rusted fixings on galvanised roof sheeting

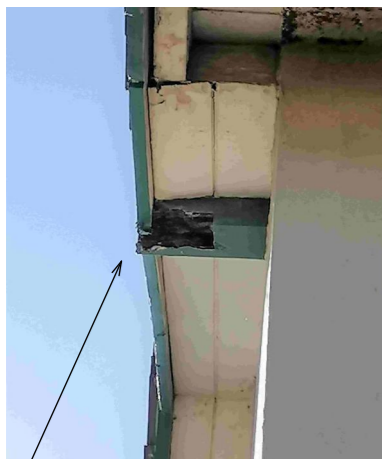
All rotten timbers to be replaced NB structural members as above

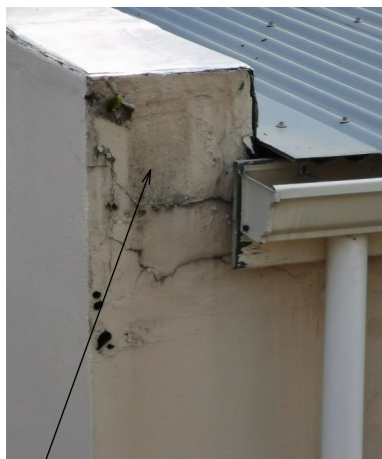
parapets require maintenance & upgrading

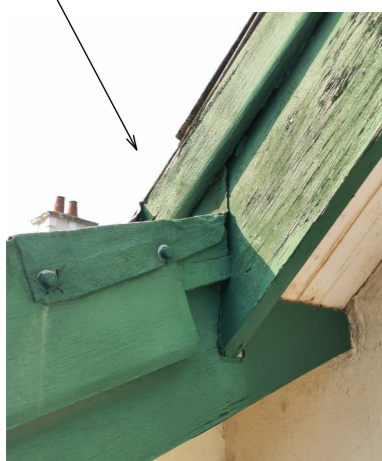
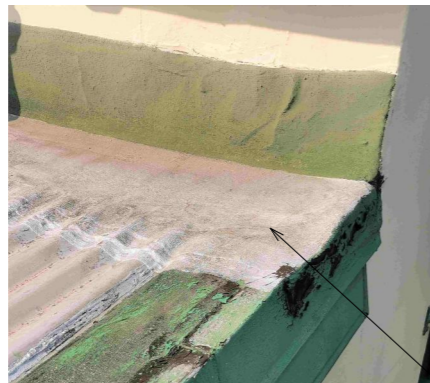
Roof above Museum back entrance porch and bathrooms in poor condition, to be replaced

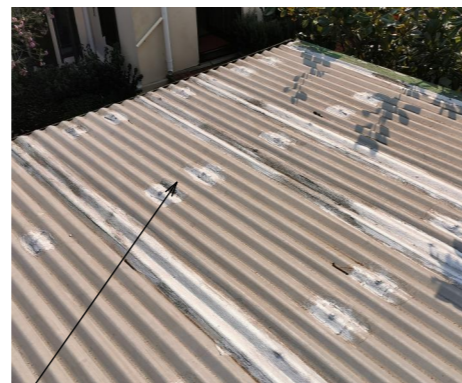
Unpainted galvanised corrugated roof sheeting in fair condition can be retained with minor repairs & maintenance

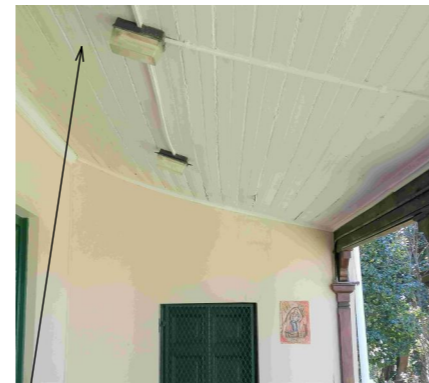
curved timber ceiling to verandah to be redone when restoring / repairing the roof & structure

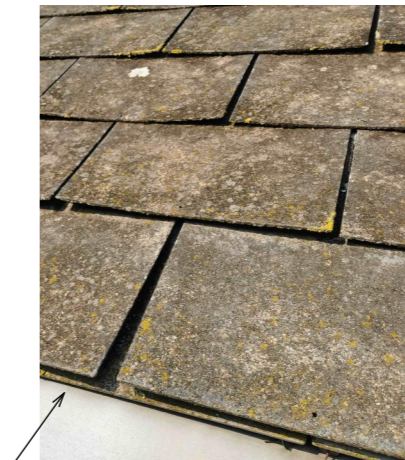
Asbestos roof tiles irreparable

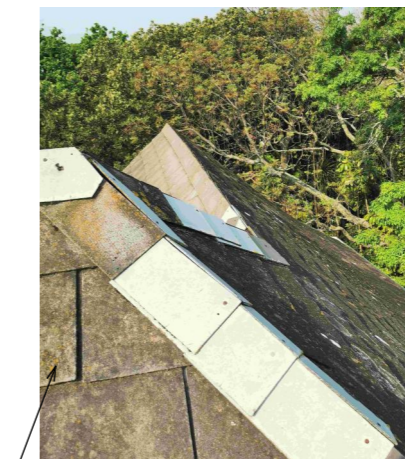
Asbestos roof tiles: all tiles are extremely brittle, curved with fixings coming loose

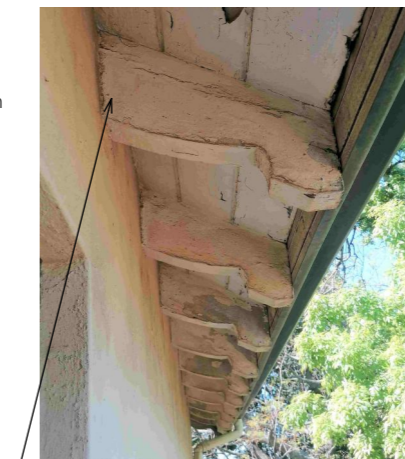
Eave sprockets, fascias and soffits to be repaired/replaced & painted

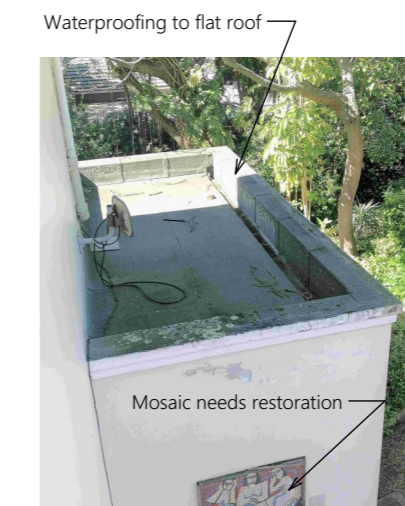
Waterproofing to flat roof

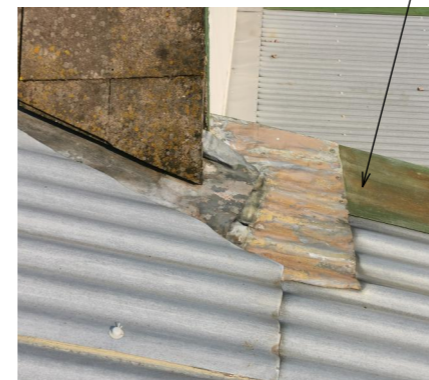
roof repairs done with mixture of new & old materials- all to be replaced

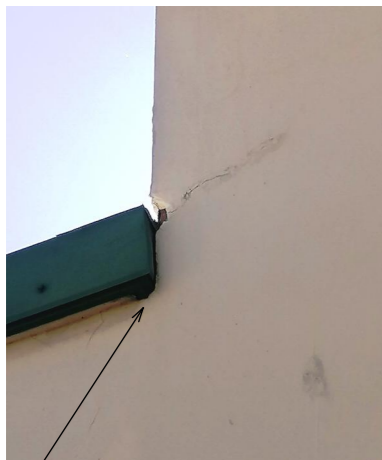
poor plaster works and flashing at roof junction

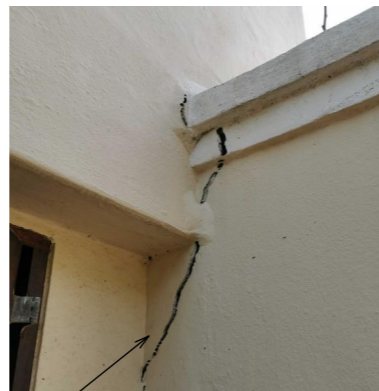
Severe structural cracking between gate pillars and coach house and Museum.

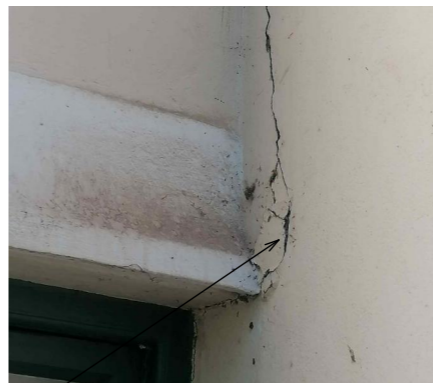
Cracks in the walls to Irma's Studio

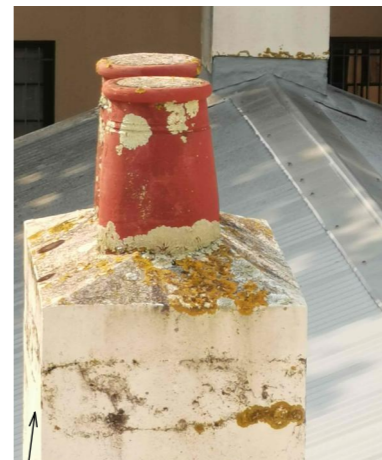
poor maintenance to the chimneys allows water ingress into the walls & structure below

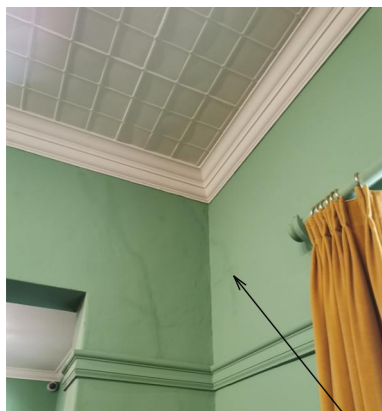
damp stains on the walls & blistering paint in the library & lounge

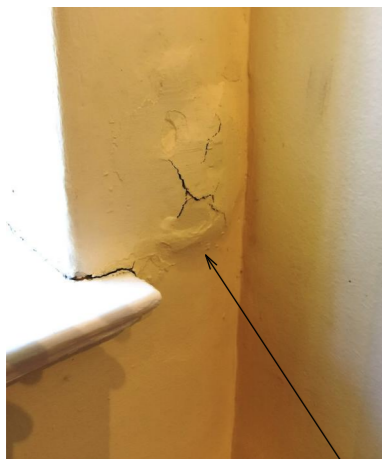
spalling plaster internally on stairwell

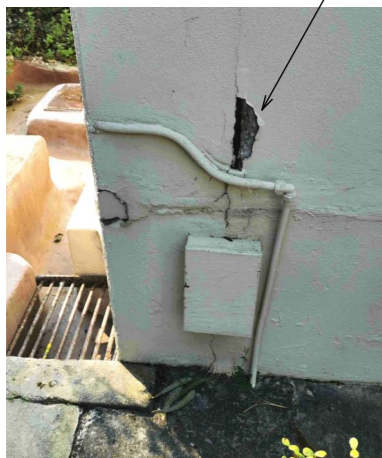
damp in walls next to a painting-blistering paint in the library & lounge

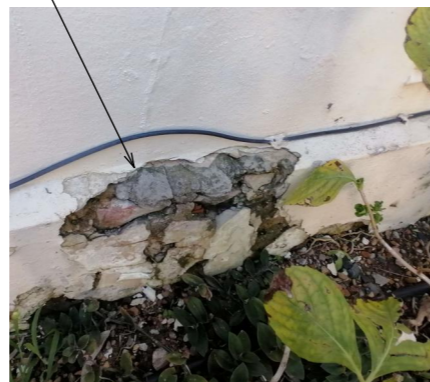
signs of parapet waterproofing failing & damp in the walls

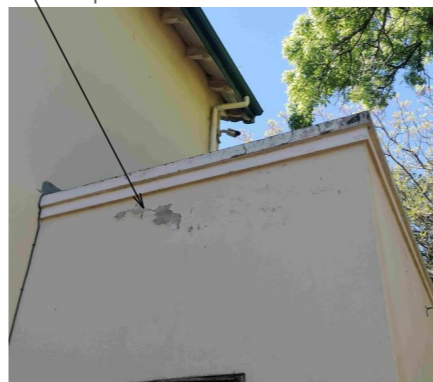
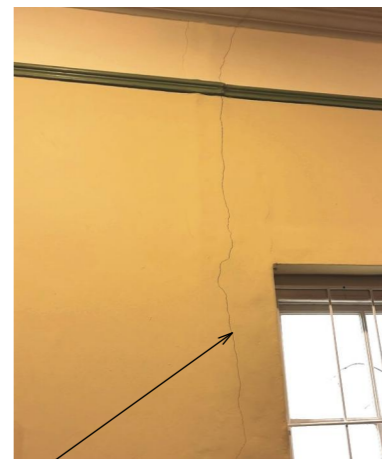
structural cracks through walls will allow water ingress & damp into the interior

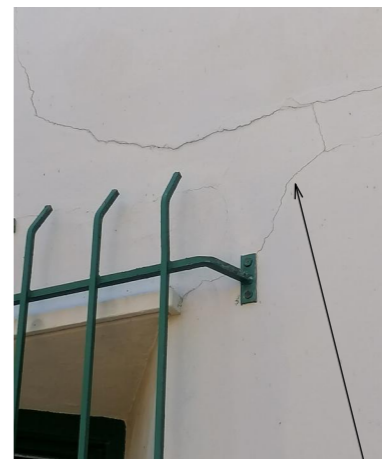
example of external plaster & structural cracks

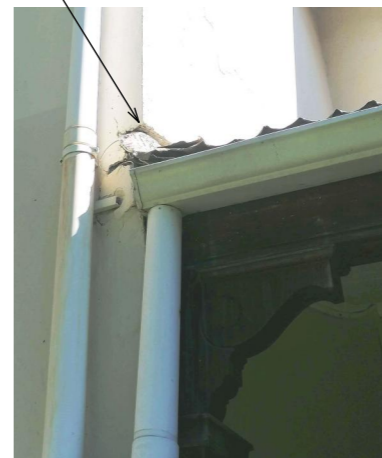
poor installation of roof flashing & counterflashings

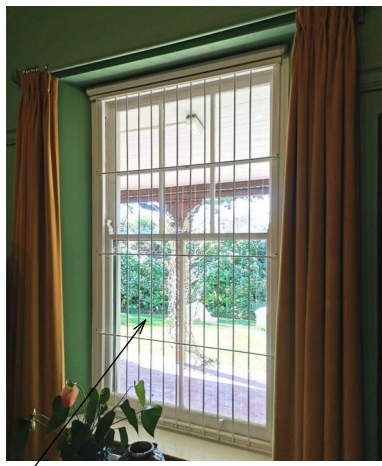
typical sash window - single glazing with inadequate burglar bars

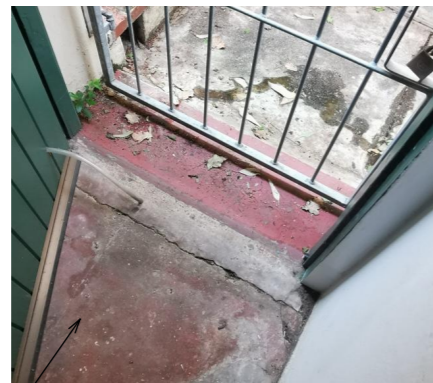
Store 1 door with no doorsill to outside or waterproofing- water free to travel under door to interior

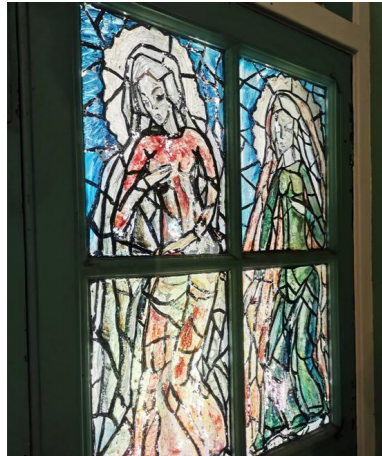
Lounge doors: Irma's handpainted 'stain glass' slowly fading

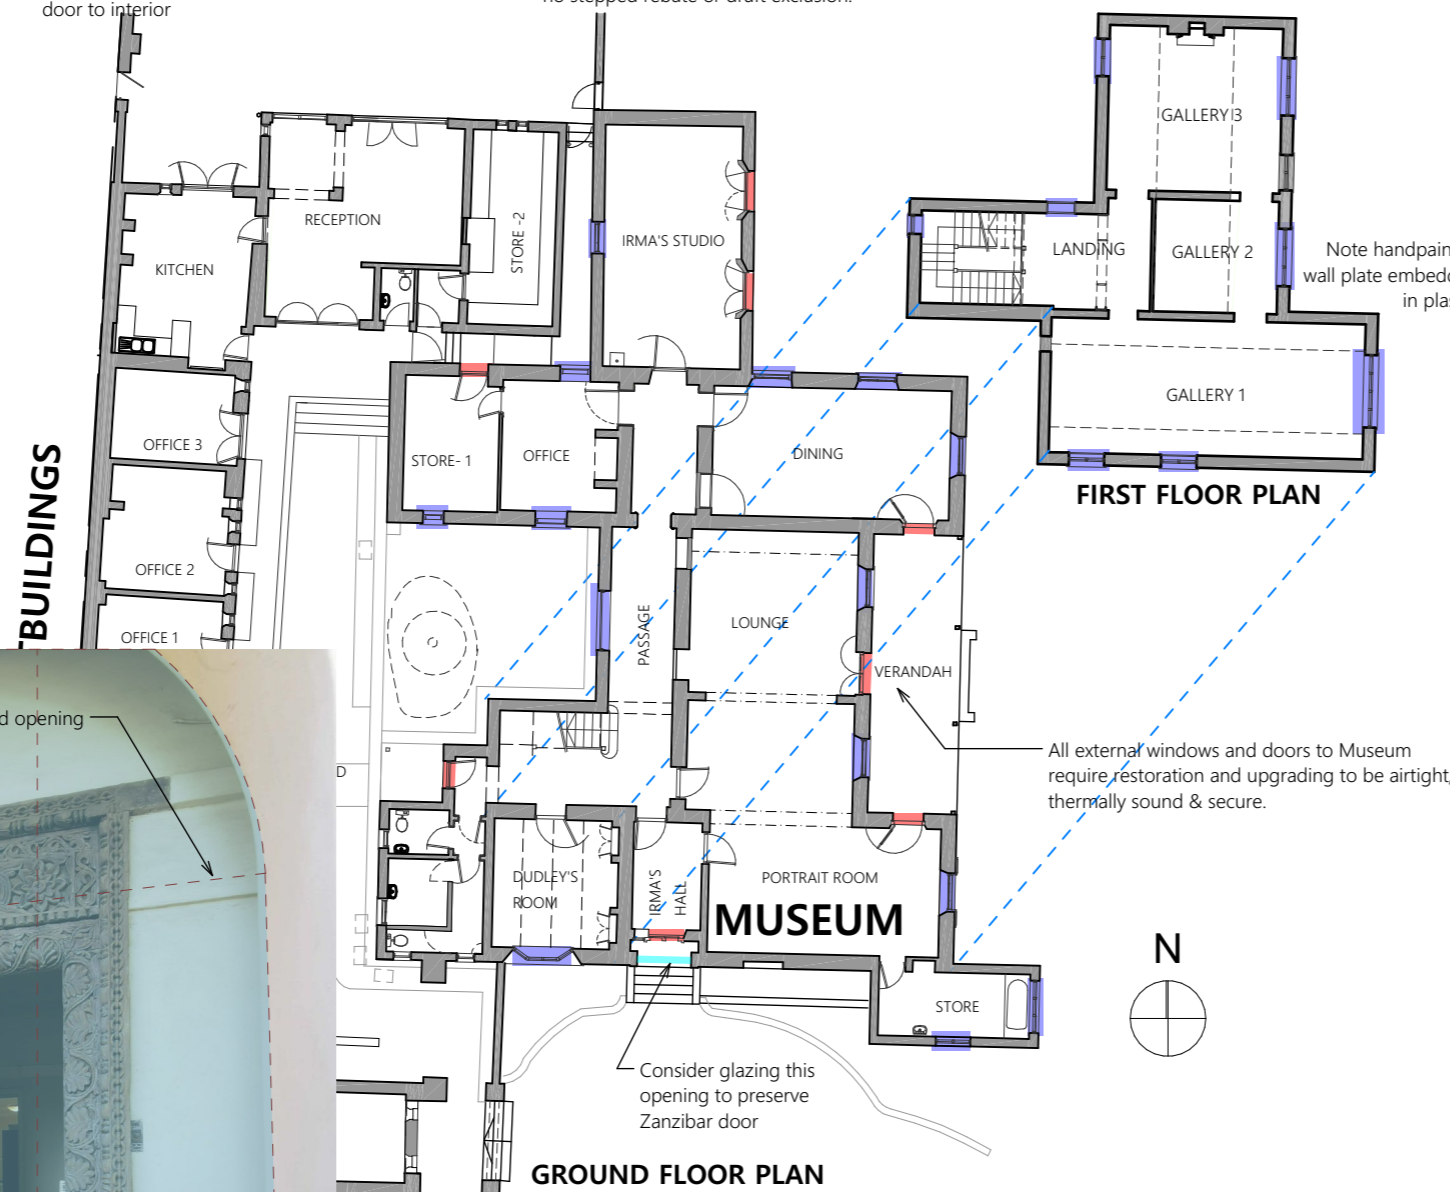
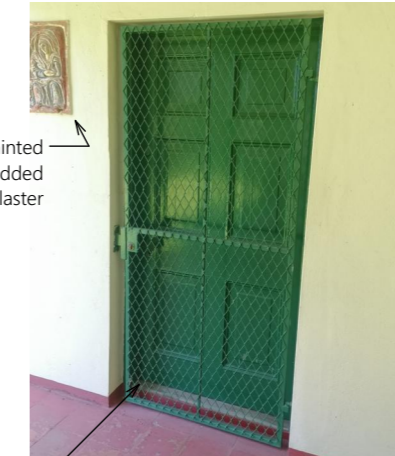
Verandah door - security gate.

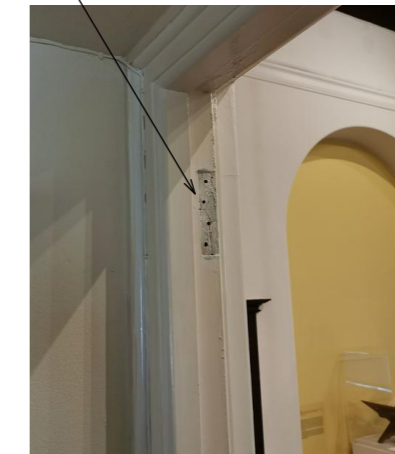
Internal door to Dudley's Room removed

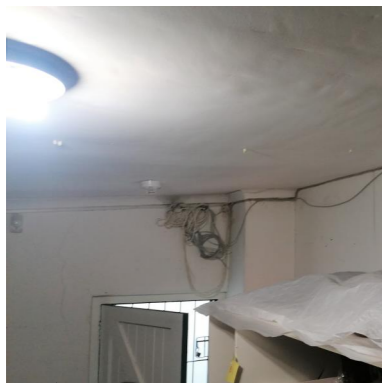
Store 1: Plasterboard ceiling damaged and sagging possibly due to water ingress. Note surface wiring and services!

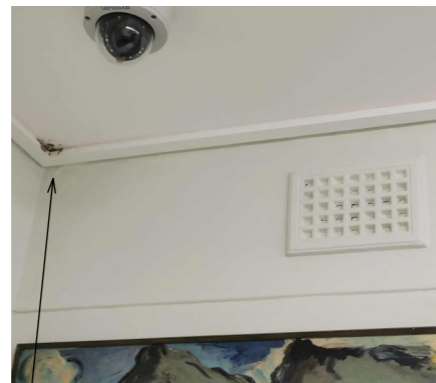
Store 2 hole in ceiling

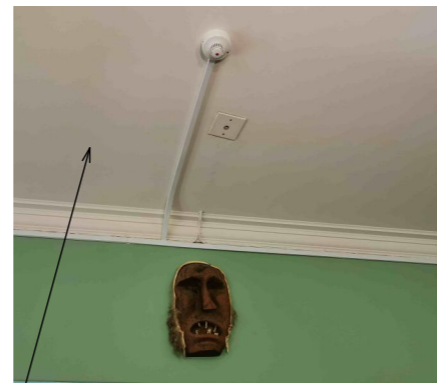
Plasterboard to Lounge - restore previous ceiling or repair with all services hidden

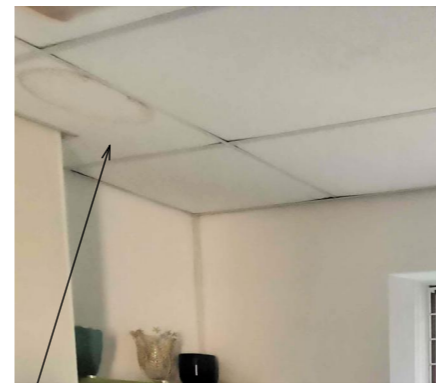
Kitchen ceiling tiles damaged

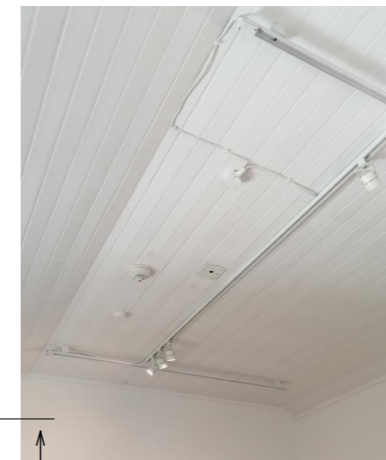
1st Floor - T&G ceilings to be restored & services rationalised

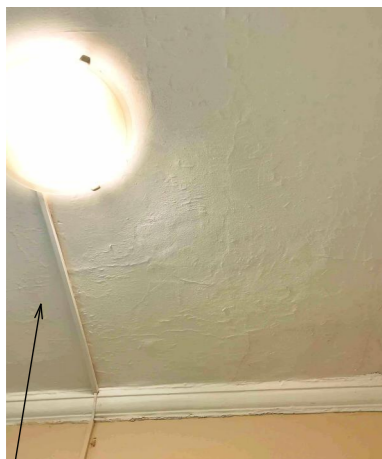
Plasterboard ceiling & cornice in passage in poor condition to be repaired / replaced with all services hidden

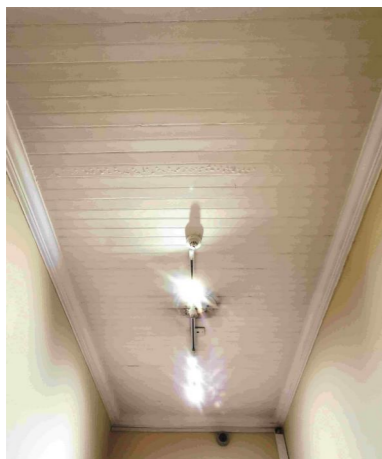
T&G ceiling in passage and stairwell. Original detail lost due to multiple coats of paint

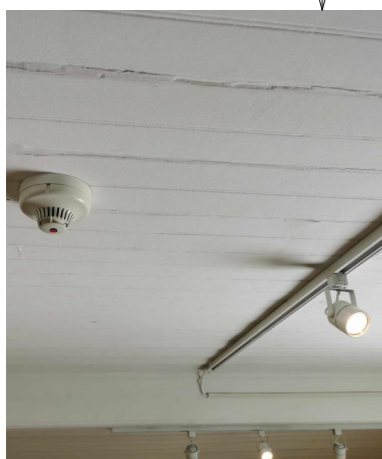
Heraklith ceiling in Works Room & old entrance in fair condition

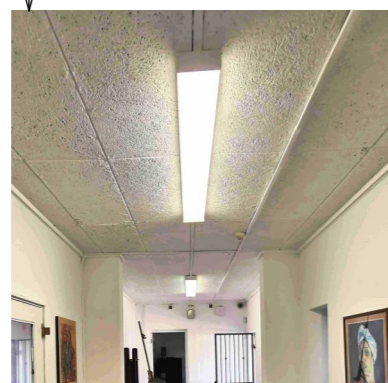
pressed metal ceilings rusted & poorly restored

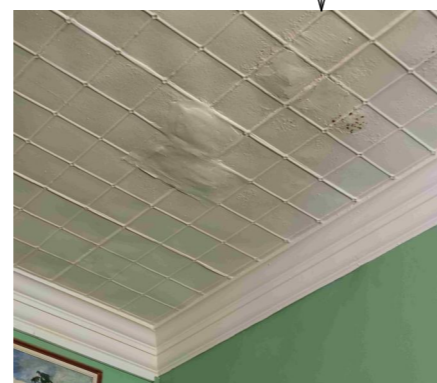
Plasterboard ceiling in Store poorly patched, to be replaced

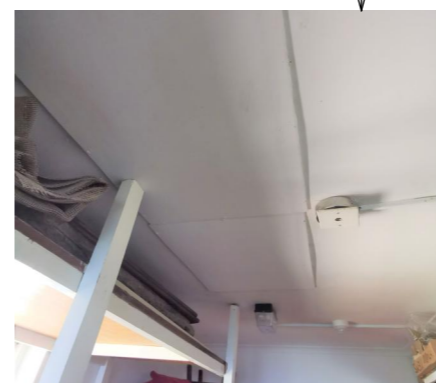
(Dining Room) Embossed wallpaper to be restored or replaced to match (now mended by UCT maintenance)

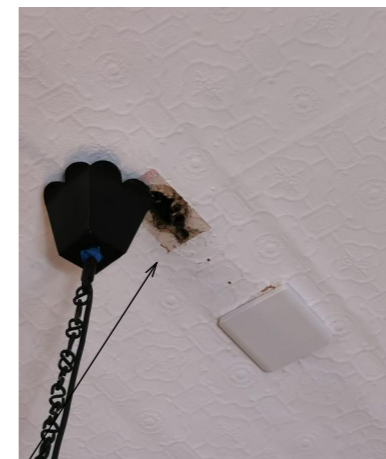
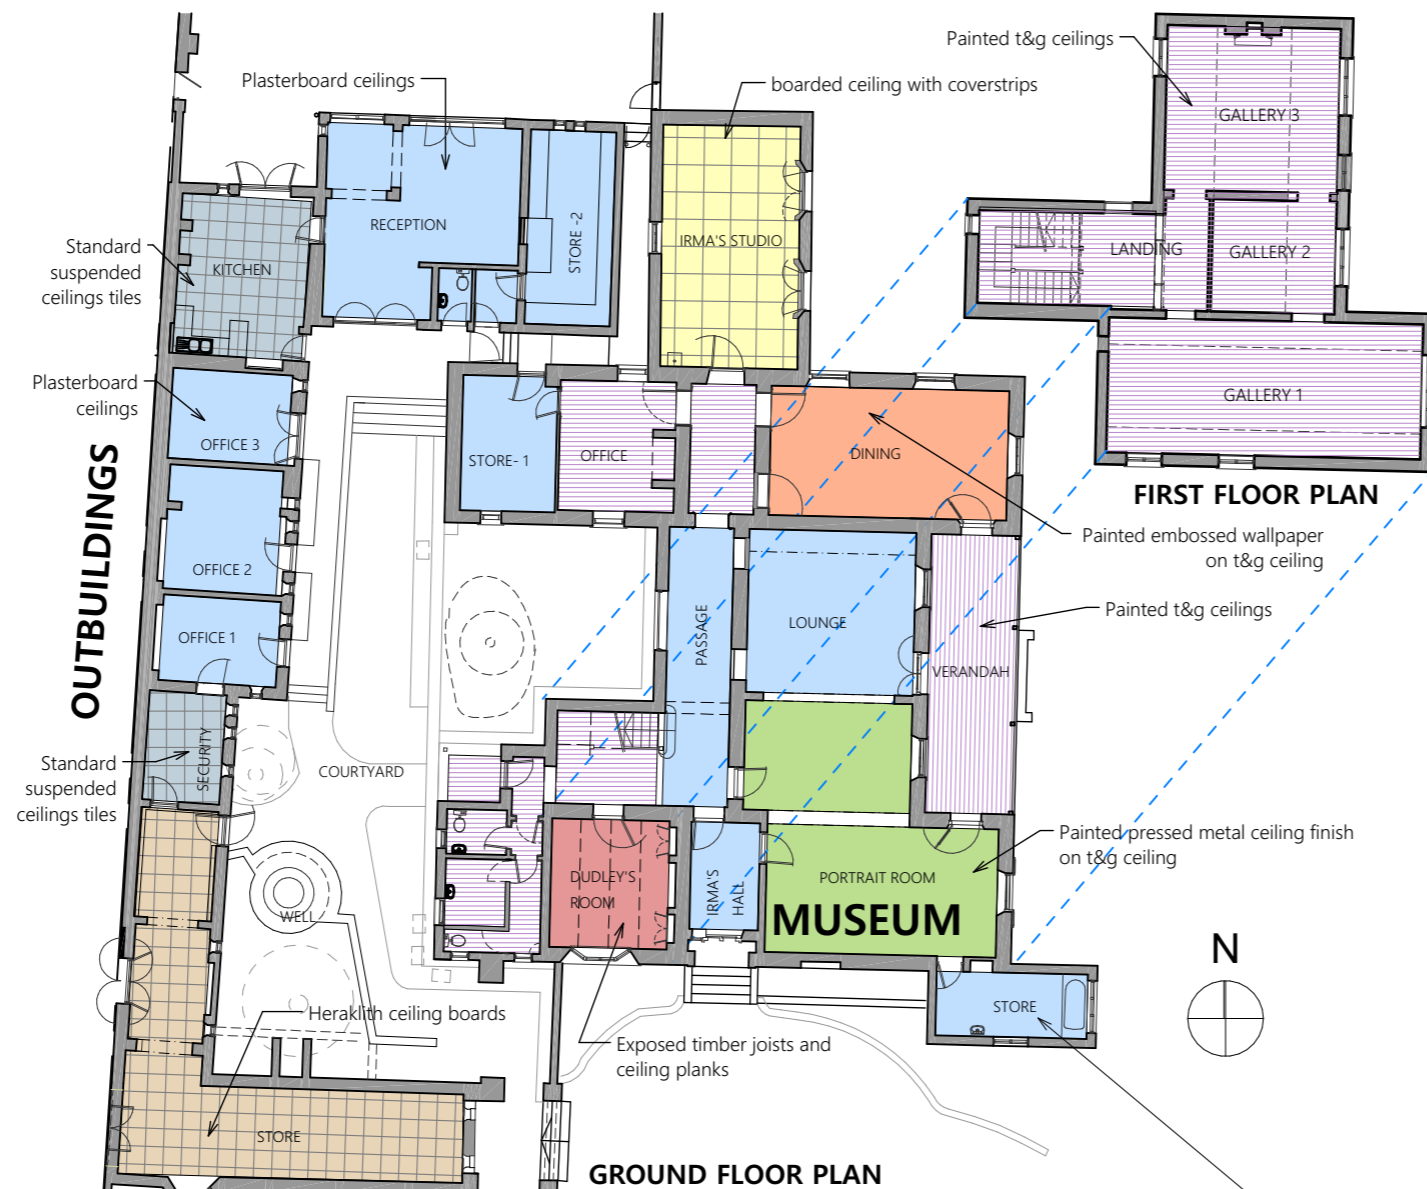
Building envelope - Ceilings

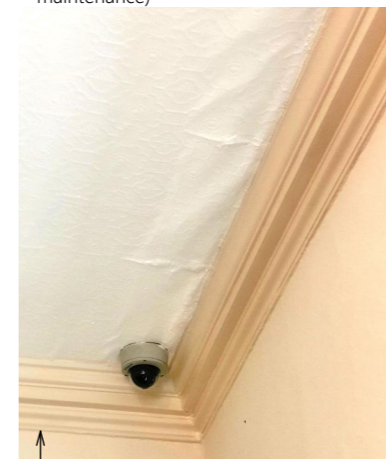
(Dining Room) Embossed wallpaper coming loose, to be restored or replaced to match

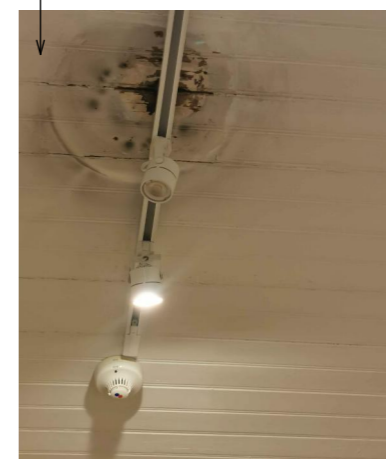
Gnd Floor - T&G ceilings to be restored & services rationalised

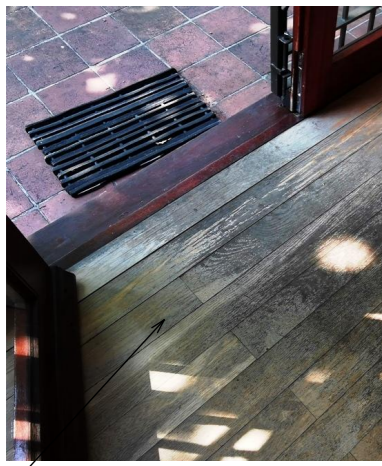
Reception room floor damage

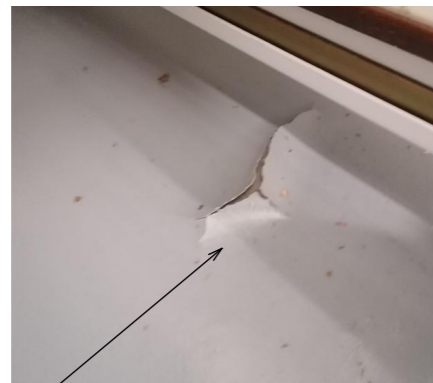
Epoxy floor failing in Store 2 & Kitchen

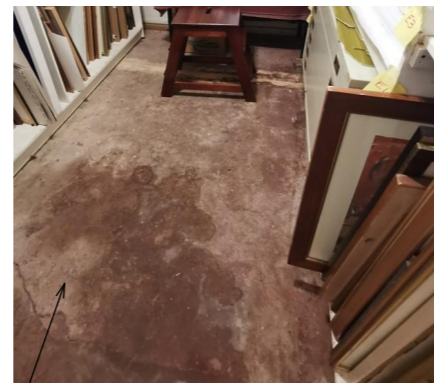
Store 1 floor screed cracked, damp, no dpm

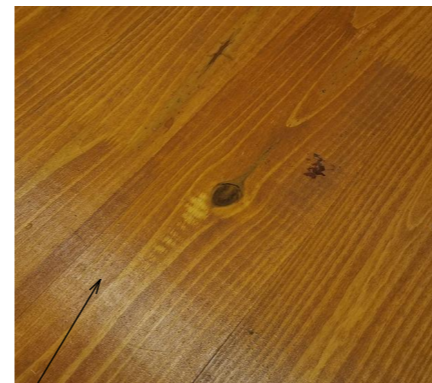
Irmas Studio floor - new SA Pine, poorly finished and structure failing

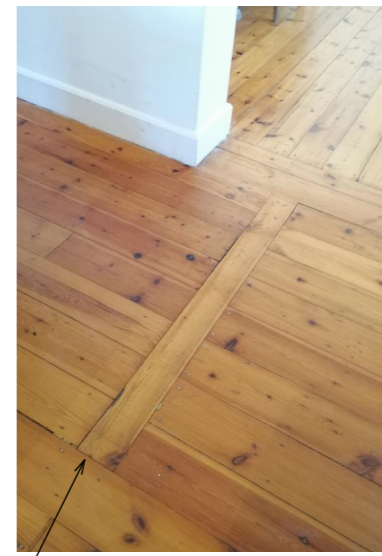
Patchwork repairs to first floors

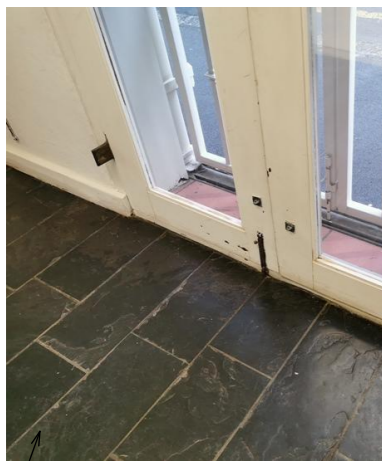
Slate tiling in previous entrance hall

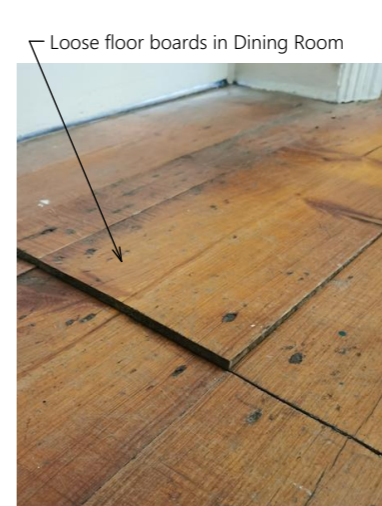
Loose floor boards in Dining Room

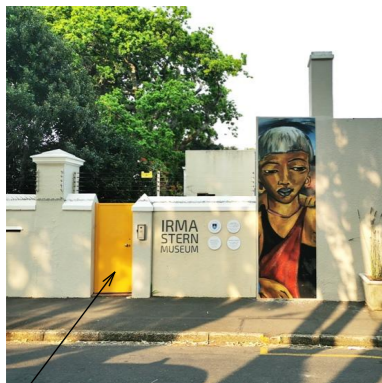
Museum (tradesman's) entrance. Is this the best place to enter?

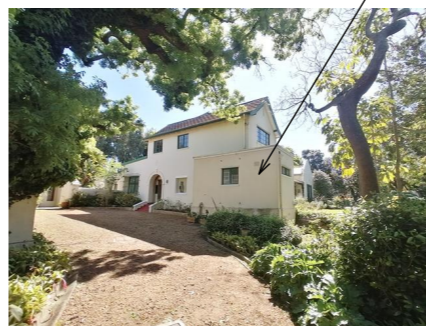
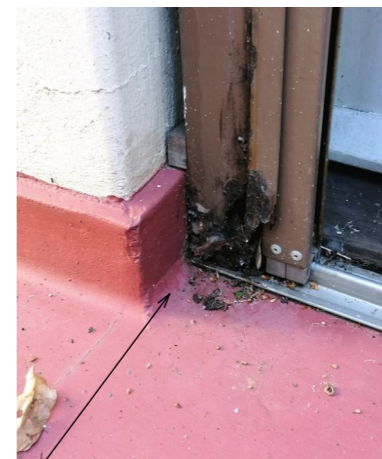
Corrosion of security shutter

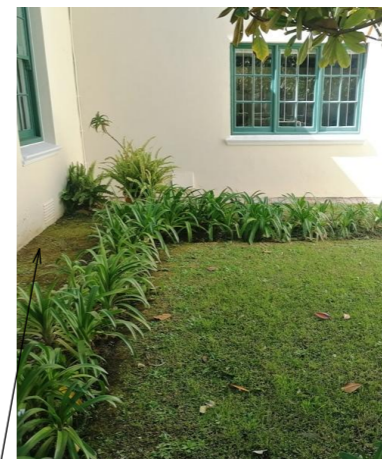
soil levels too high in relation to the internal floor levels

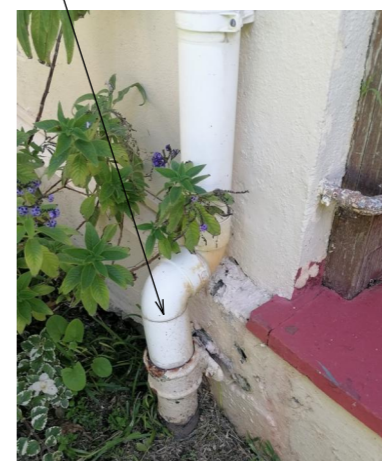
generally the down-pipes & storm water disposal needs to be upgraded to avoid excess moisture around the structures

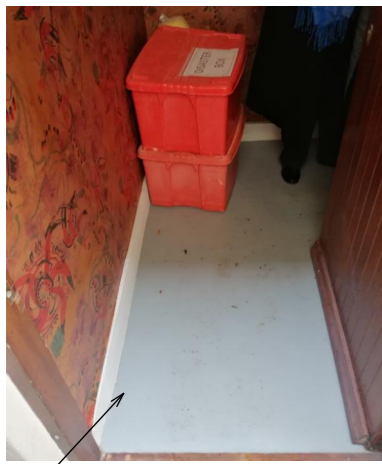
Difficult access into Store 2, & insecure being directly from the outside

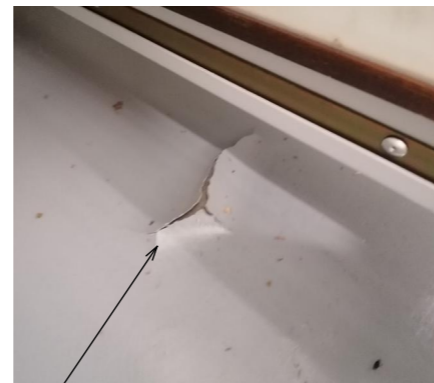
Failing epoxy finish to floor in Store 2

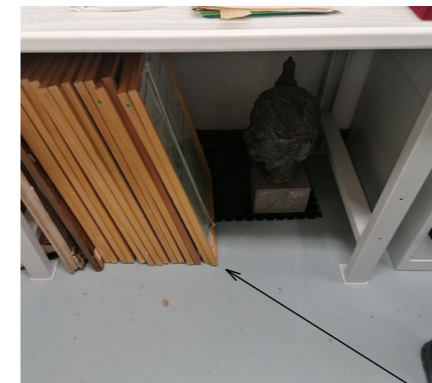
Artworks stacked on the floor due to the lack of space

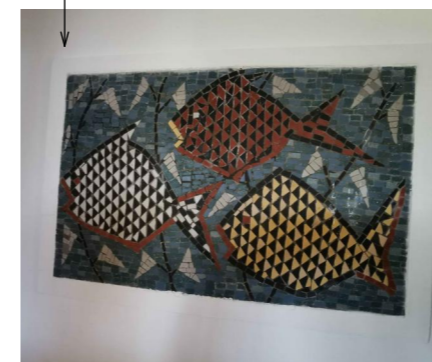
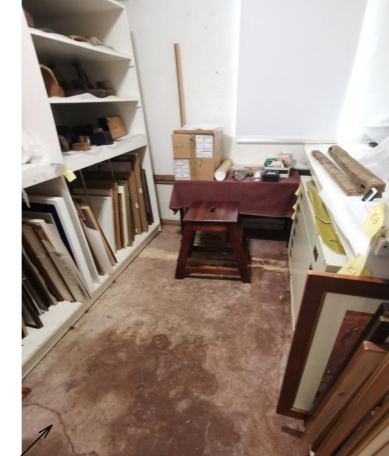
Store 1 is unsuitable as an Archive store. Too small, excessive damp with visible water seeping through the cracked, screeded floor. Inadequate and unsuitable storage units. Dusty, mouldy and insecure

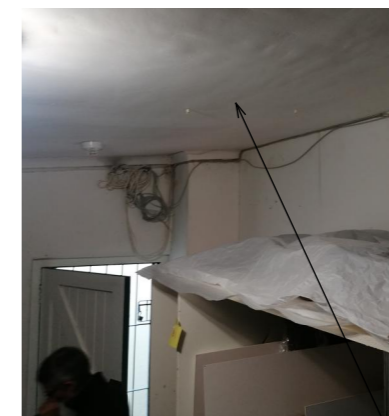
Store 1 ceiling water damaged, poor wiring inappropriate shelving, external door

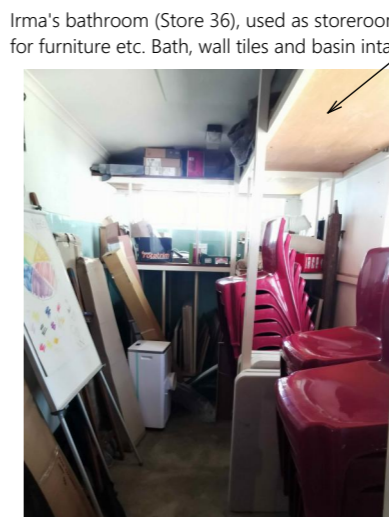
Irma's bathroom (Store 36), used as storeroom for furniture etc. Bath, wall tiles and basin intact

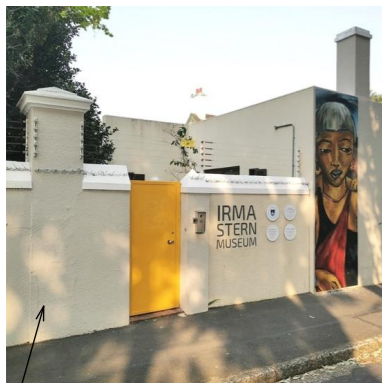
security & access control installations at the main entrance are unsightly

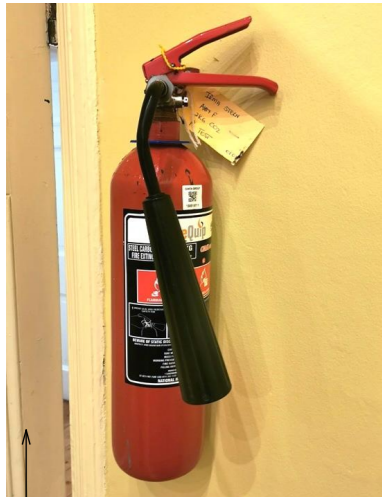
fire extinguishers are inadequate fire control & will damage the artworks

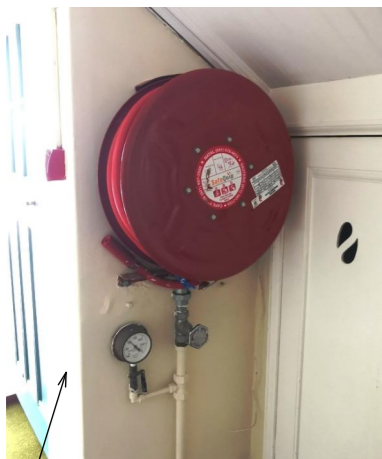
fire hose reel in passage - NB water as a means of fire fighting will be catastrophic for the artworks

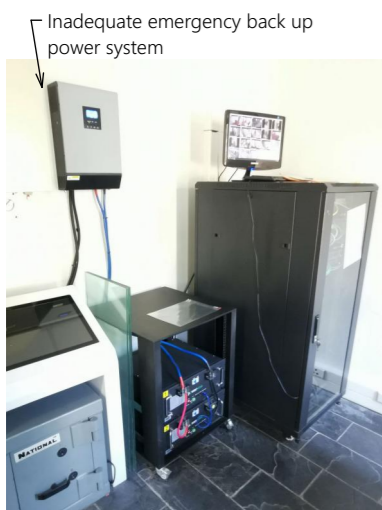
Inadequate emergency back up power system

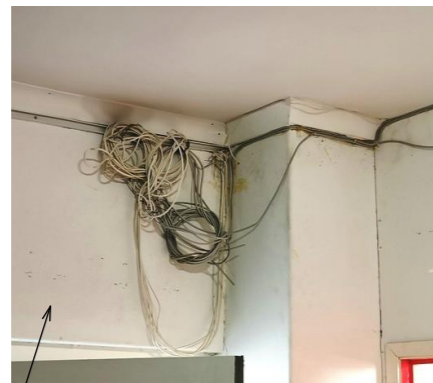
Store 1- multiple & redundant cables for data & other services are poorly installed and can not easily be maintained in the current layout

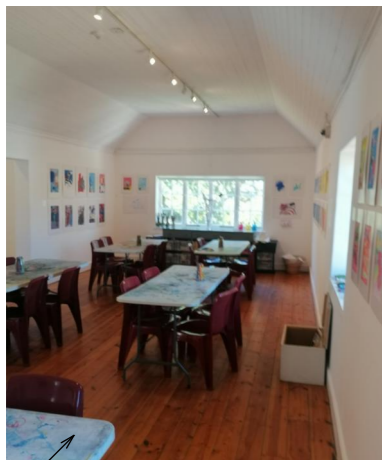
High UV and light levels, and insufficient artificial lighting

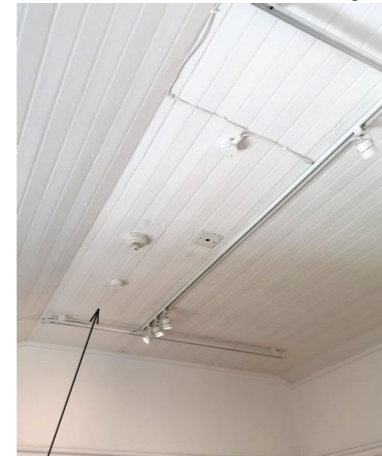
uncoordinated layout of lighting, alarm & fire installations to the 1st floor degrade the ceilings

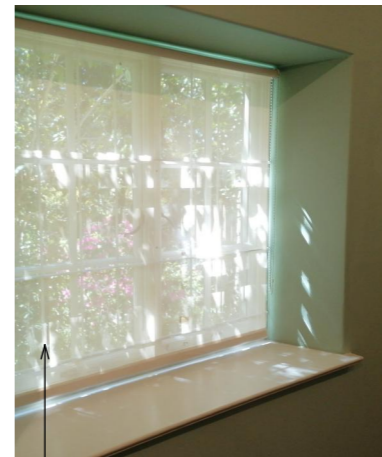
Check if blinds fitted are UV resistant

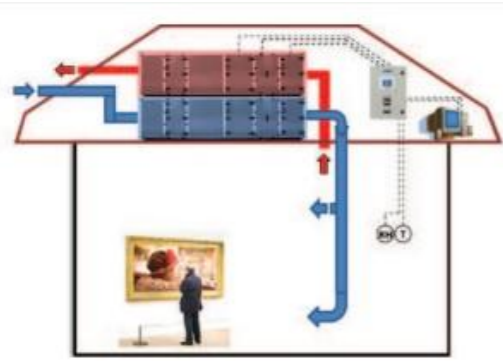
Installation of the environmental control system will require considerable intervention, careful reticulation and design to ensure it does not clash original Museum interior

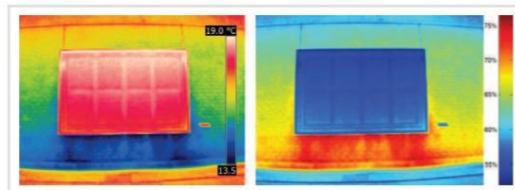
Figure 7. Example of a seventeenth-century painting hung on an un-insulated external wall in a museum that is conditioned to 20 °C and 50 % RH. The thermal image shown left, is taken during winter time. Clearly visible is the cooler surface under the painting. The right image shows a hygrograph with the calculated surface RH of the same situation. It can be expected that the RH behind the painting is well over 75 %

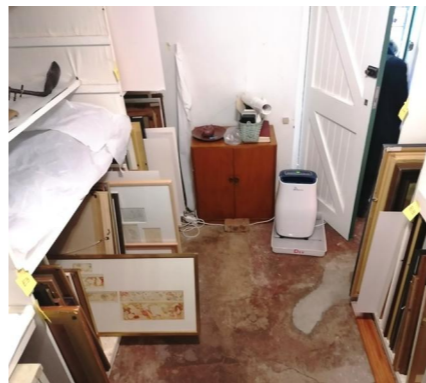
Store 1 -The freestanding dehumidifier restricts the normal use of the space

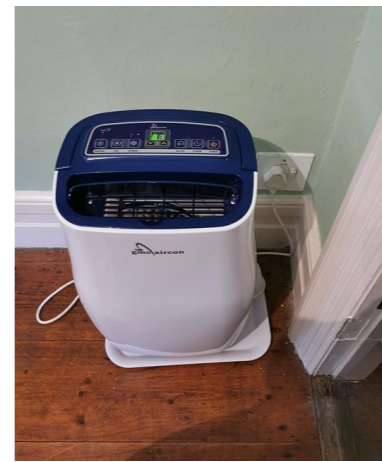
Dehumidifiers installed do not guarantee stable RH and temperature levels.

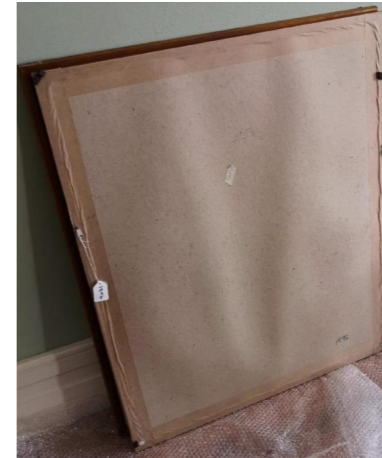
Examples of artworks damaged from damp and poor environmental controls

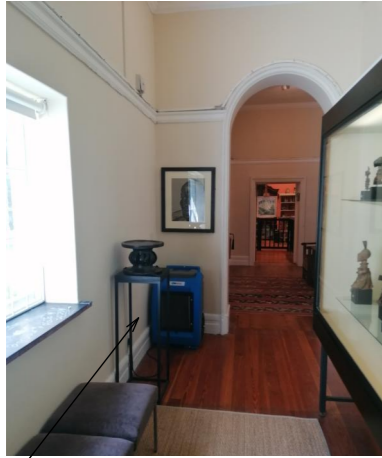
The dehumidifiers are an inadequate long term solution to environment control

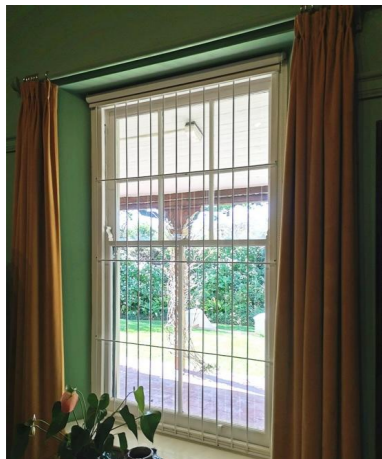
Opening windows not suitable for environmental control

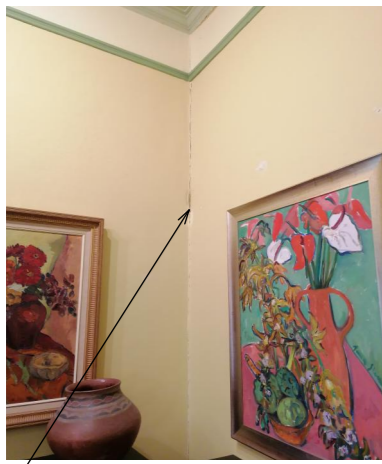
Paintings on display with structural cracking in corner and ongoing repairs to plaster in Irma's Studio

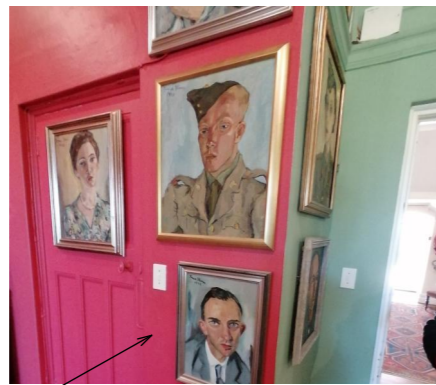
Paintings mounted too close to wall corner, vulnerable to damage ...not enough wall space?

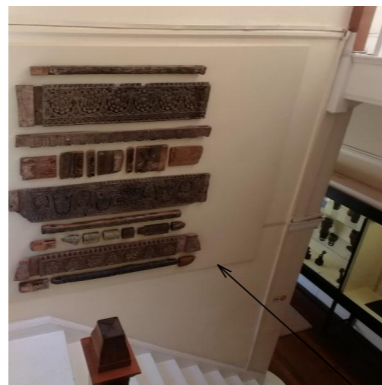
Artifacts on stairwell vulnerable to damage, theft

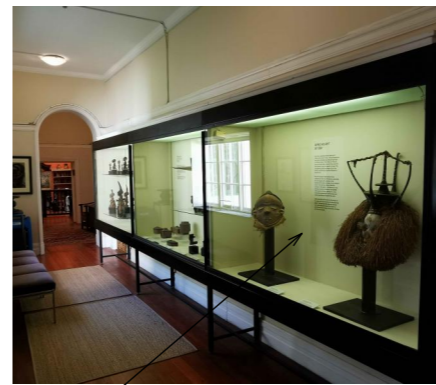
Glass cabinet in passage dominates, making circulation awkward

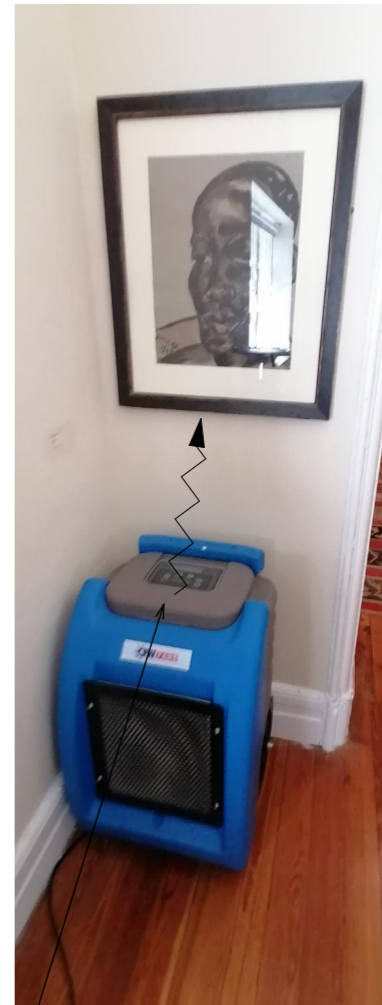
Dehumidifier blowing hot air onto artwork

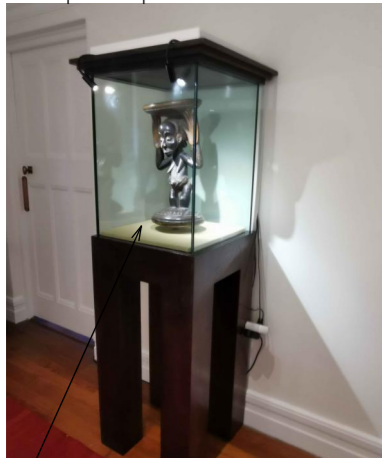
Artefacts display in Irma's Hall

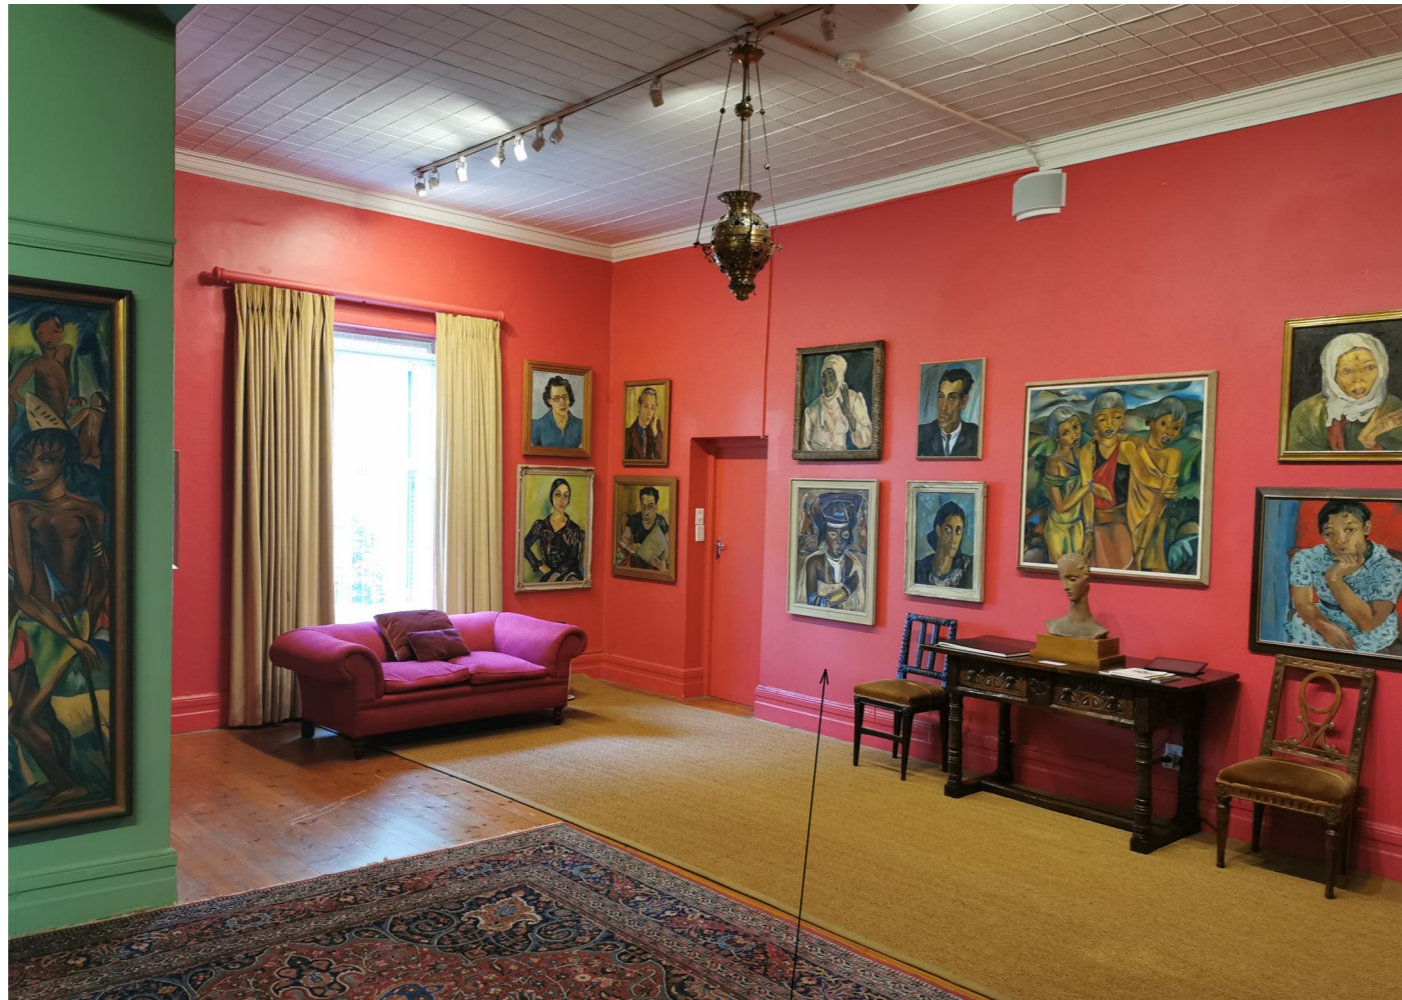
Most artworks are displayed on external walls vulnerable to temperature changes and high moisture content in walls

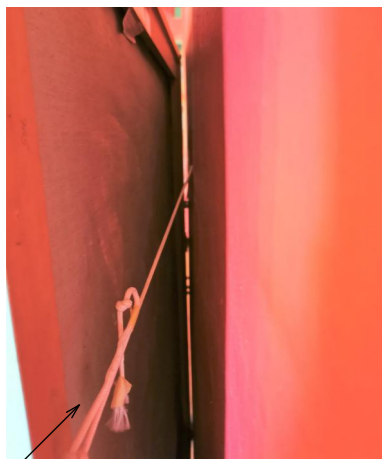
Painting hung with cord and picture hook
