INDEPENDENT CONDITION ASSESSMENT OF THE IRMA STERN MUSEUM

THE FIRS - ROSEBANK
CAPE TOWN

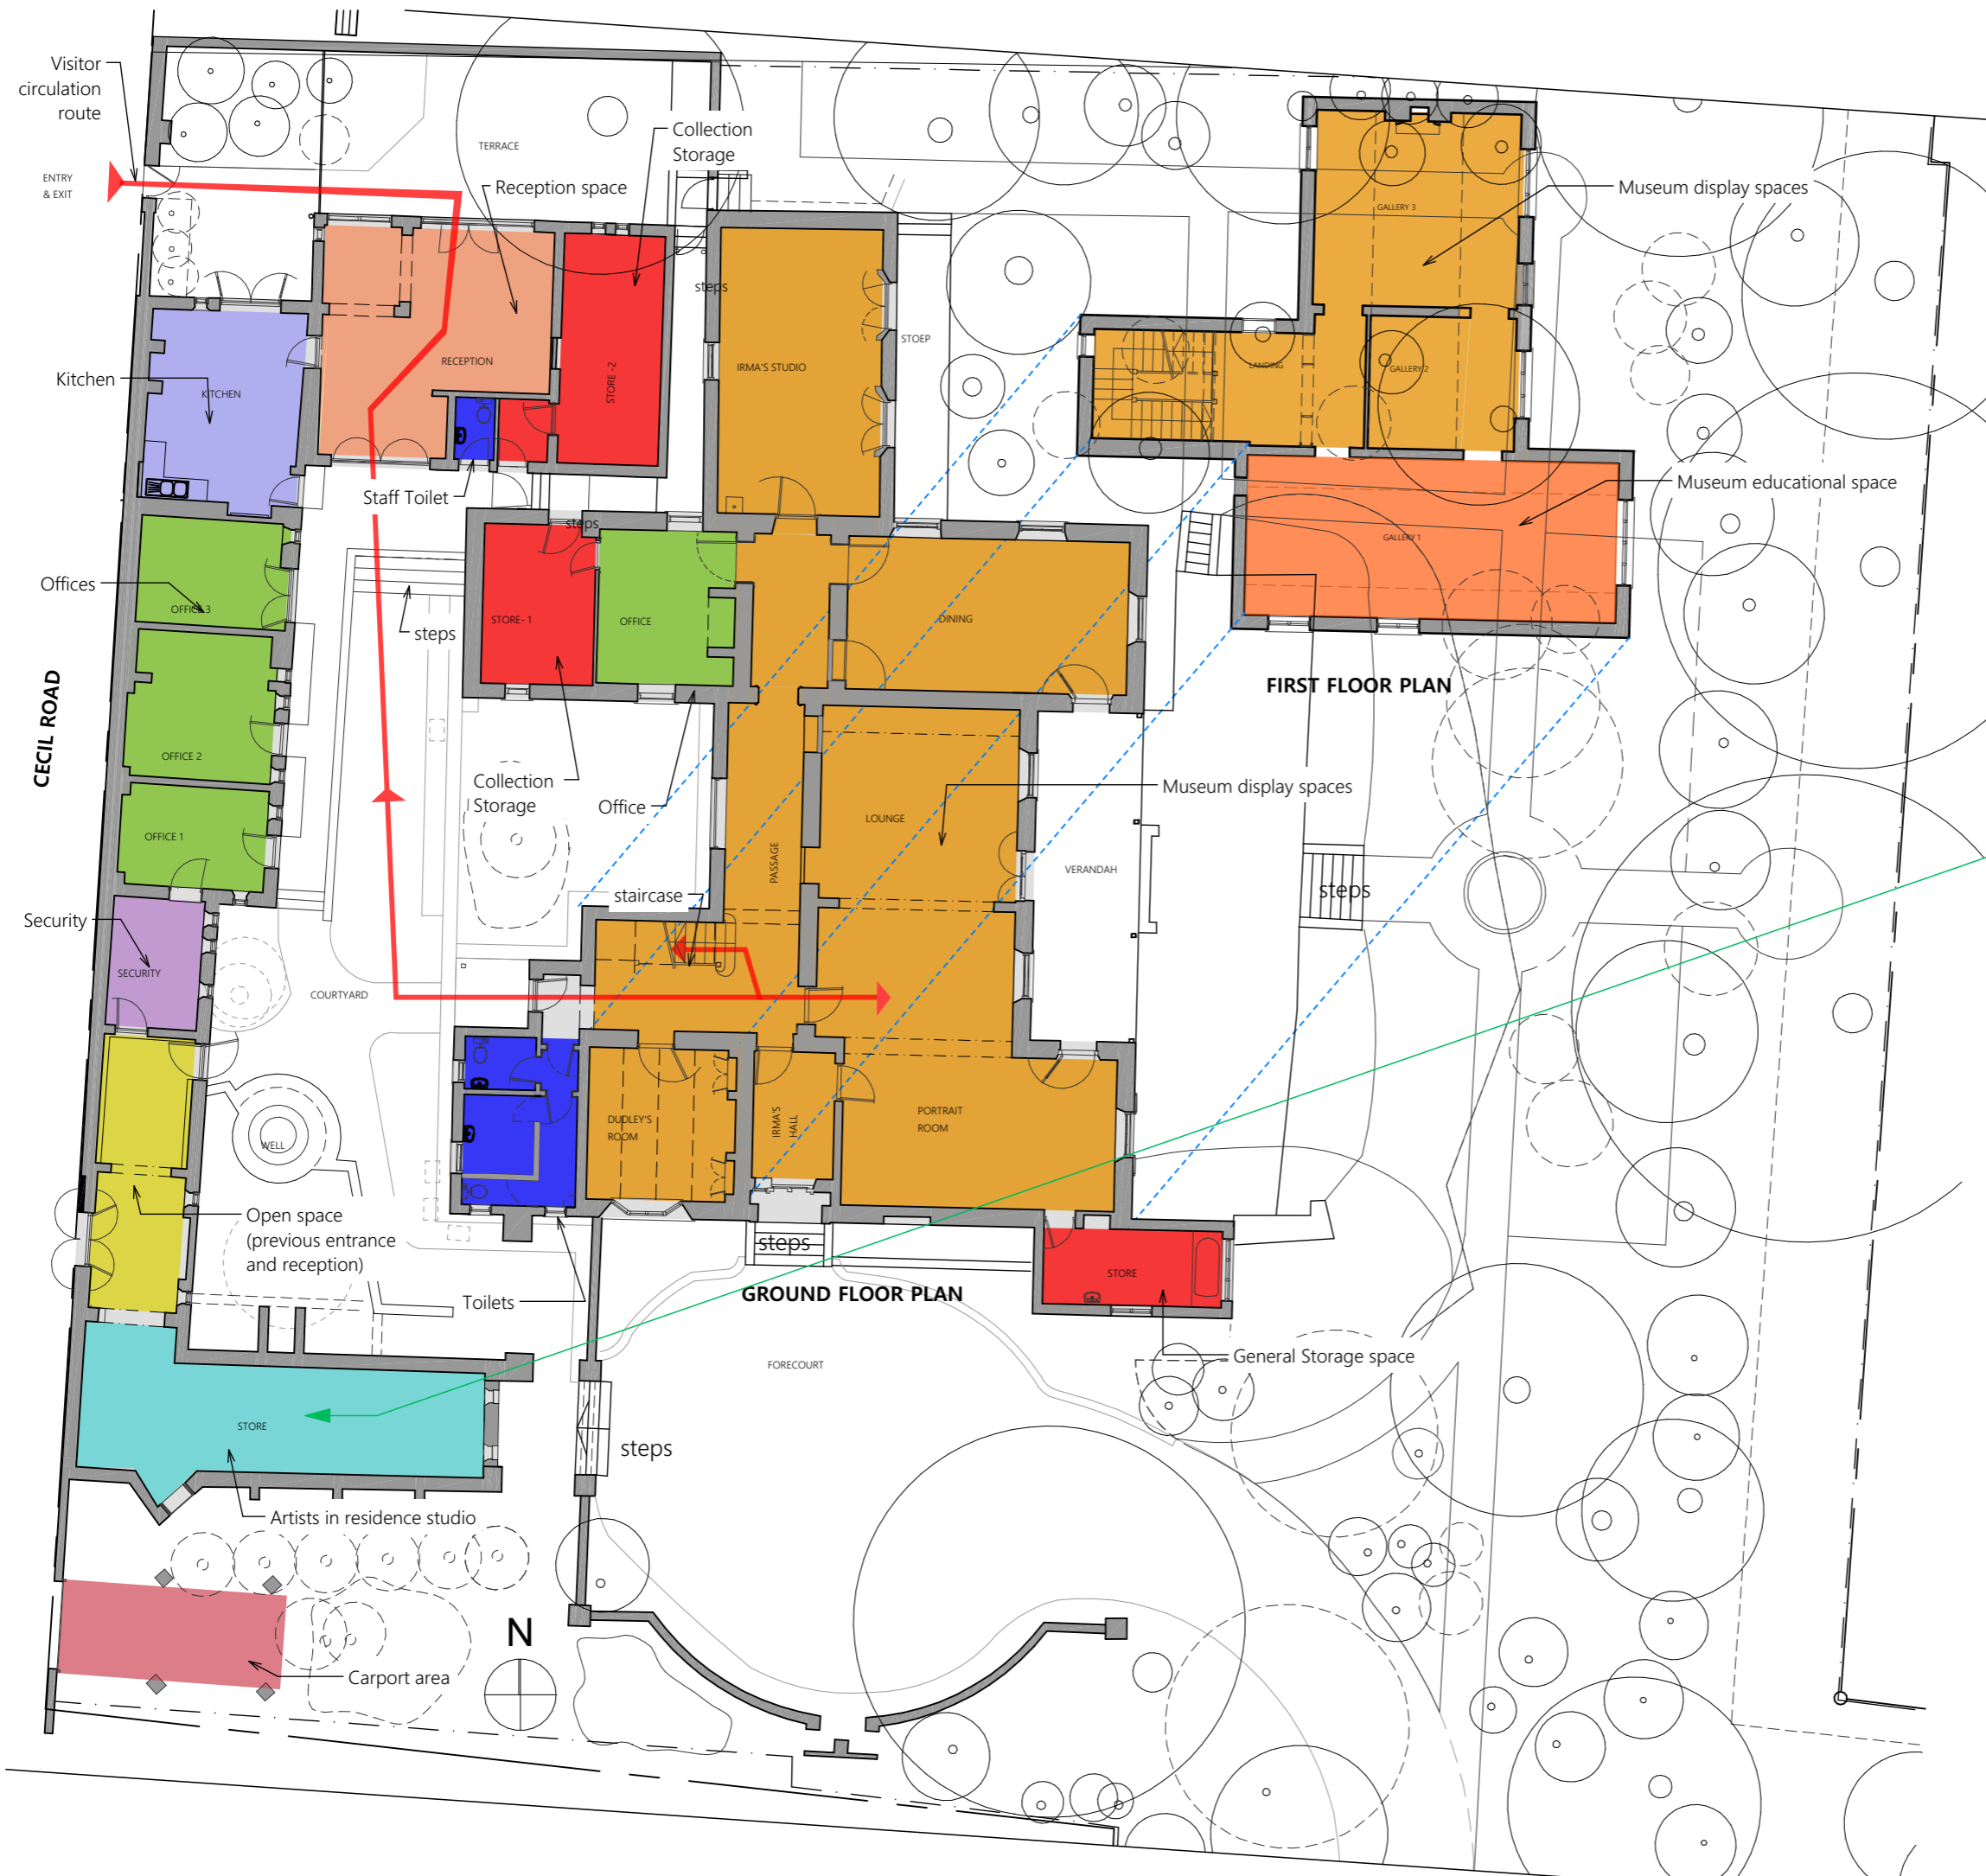
- The storerooms for the Irma Stern Collection are too small and under equipped.
